# Clearview Intelligence Connex Software Image V1.22 Release Note

1A

24/07/2024

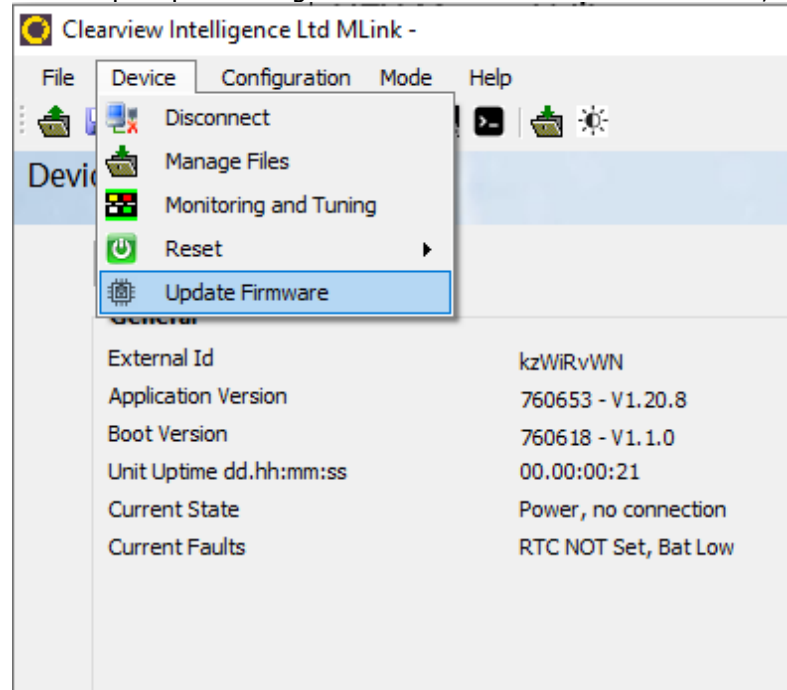
Downloadable through MLink Device > Update Firmware > Start Firmware Update

This will prompt a loading bar. Please note the Connex will reboot, disconnecting it from MLink.
